CALSPAN ON-SITE AIR BAG DEPLOYMENT INVESTIGATION

CALSPAN CASE NO. 95-09

VEHICLE #1 - 1992 FORD TAURUS GL STATION WAGON (AIR BAG EQUIPPED)

VEHICLE #2 - 1989 CHEVROLET S10 PICKUP TRUCK

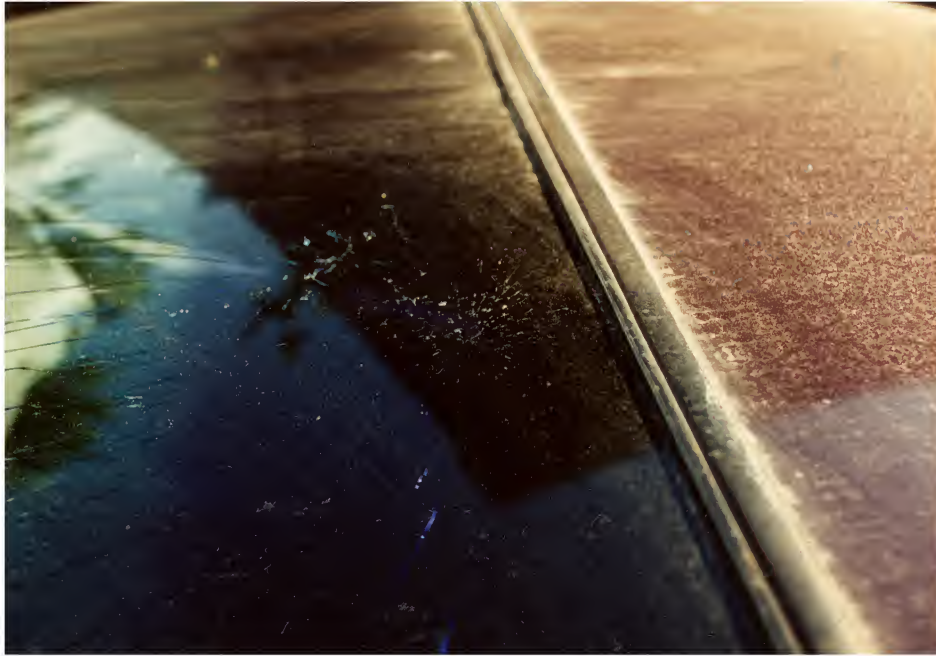
The windshield exhibited a spider web contact pattern which was consistent with an occupant hand contact. It was located 21.6 cm (8.5") left of the vehicle centerline and 11.1 mm (0.4") below the windshield header. Although the driver did not report any correlating lesion, this damage was probably caused by contact of the driver's right hand during the crash.

21. Close-up view of the interior contact evidence on the windshield near the windshield header.

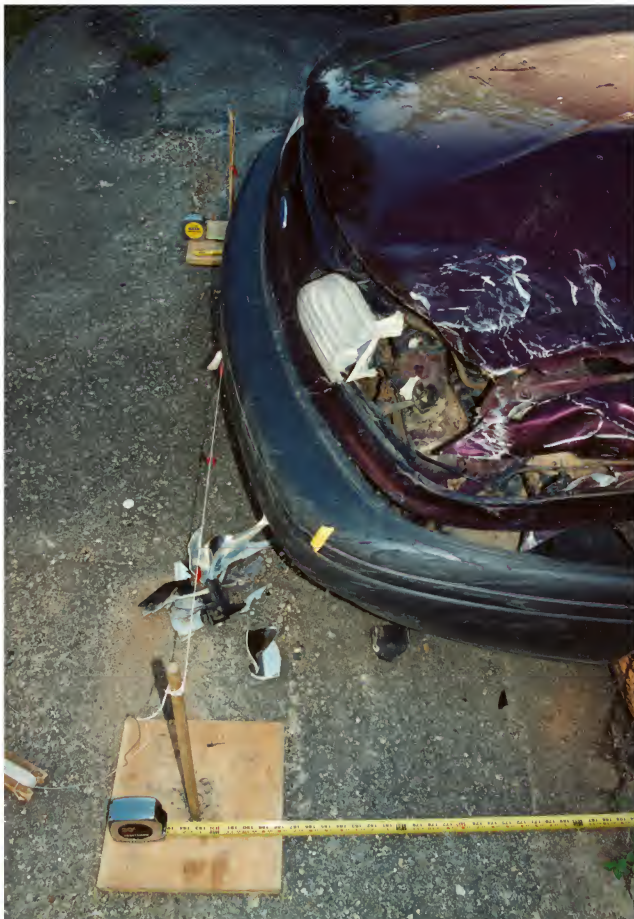
The frontal plane of the 1992 Ford Taurus GL station wagon struck the frontal plane of the 1989 Chevrolet S10 pickup truck. Direct contact was noted at the left front corner of the bumper surface, grille, and hood area. The front bumper sustained a maximum rearward displacement of 3.8 cm (1.5") and the left corner of the hood was displaced rearward a maximum of 38.1 cm (15.0"). The combined direct and induced damage length measured 139.7 cm (55.0") (refer to photographs #18, #19, #22 - #25 on pages A-9, through A-13). Measured crush values are listed below:

22. Lateral view showing the longitudinal displacement of the bumper and hood.

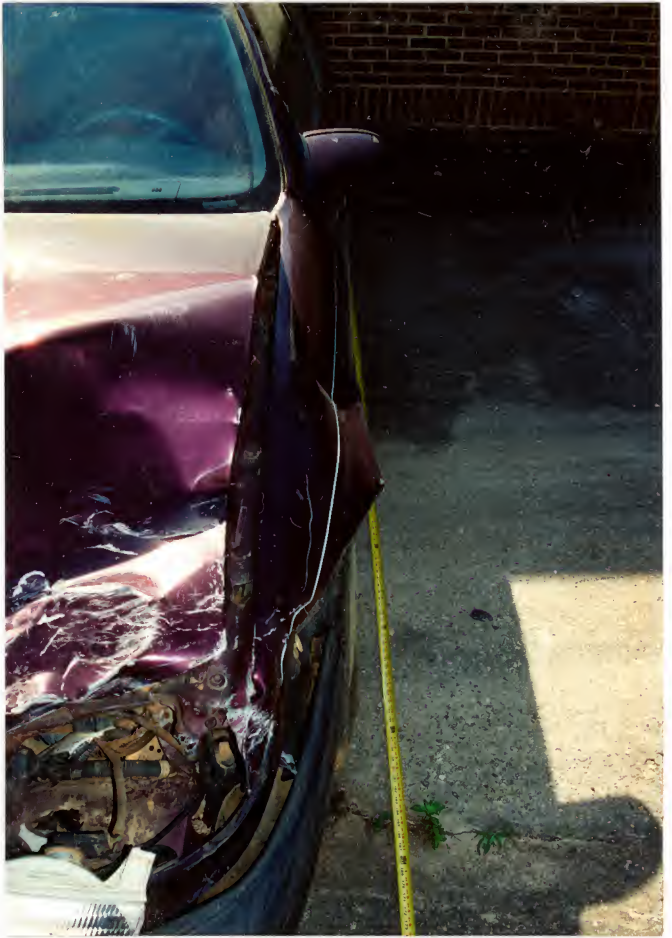
23. Longitudinal view along the left side plane.

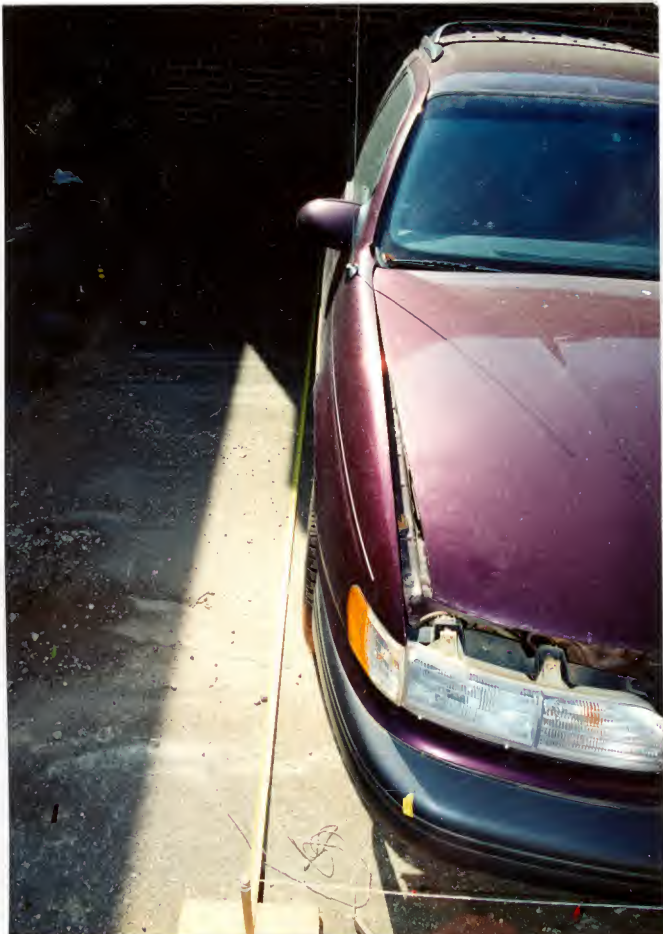
24. Longitudinal view along the right side plane.

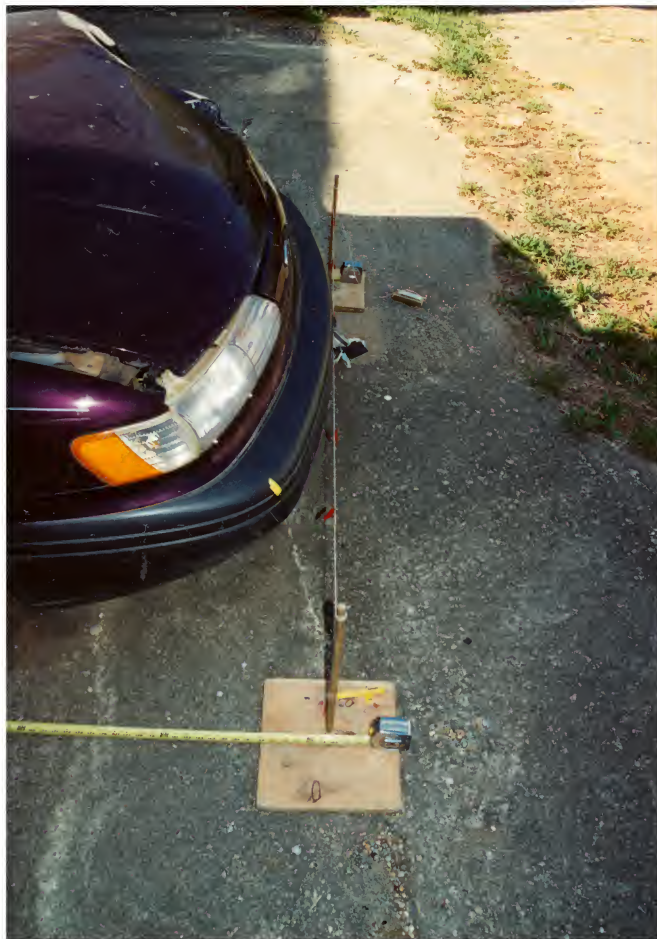
25. Lateral view from the right side of the vehicle showing the minimal longitudinal displacement of the bumper and hood.

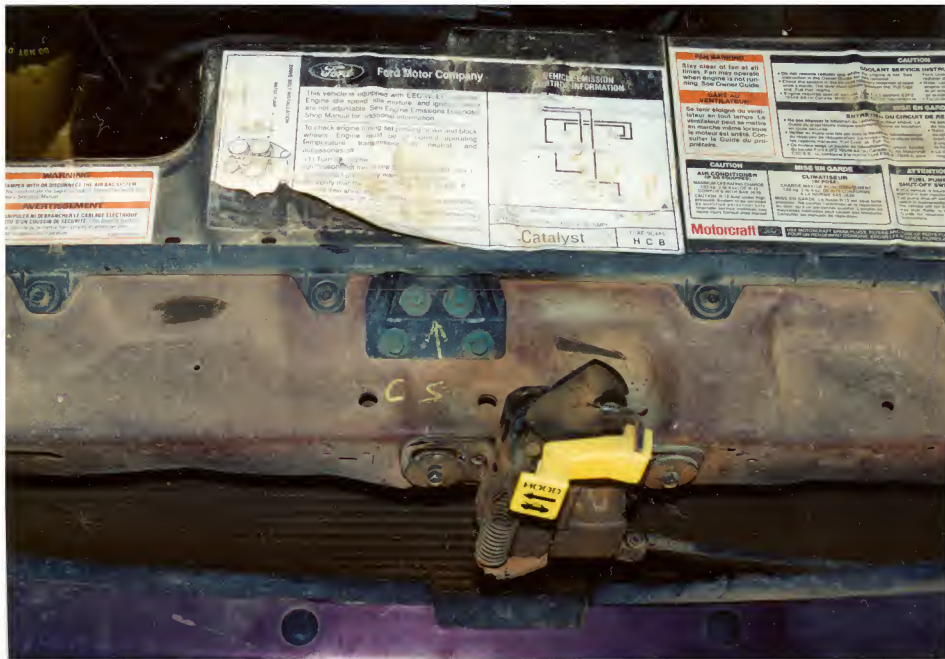
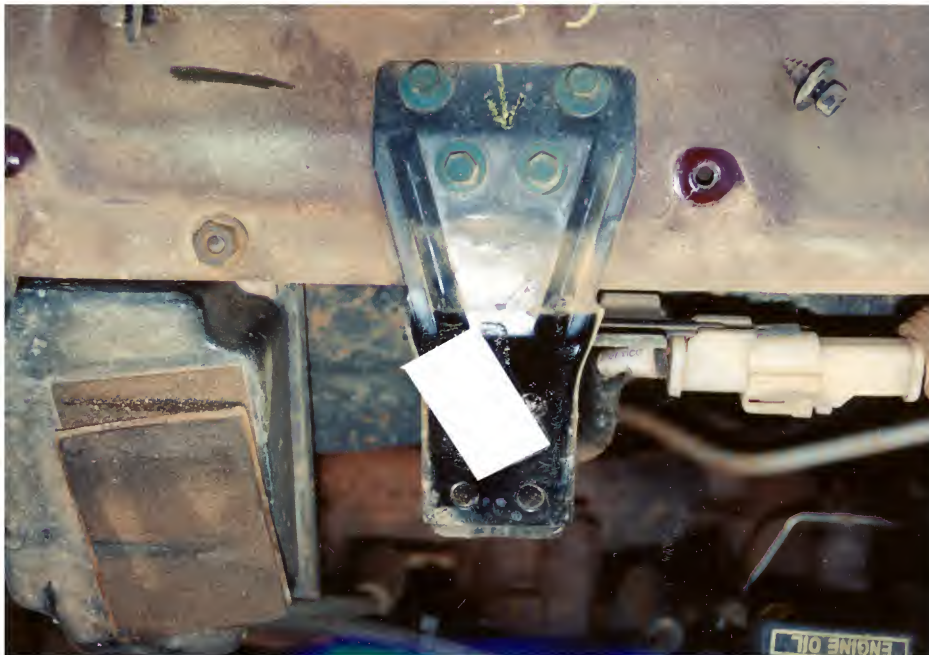
The forward most primary crash sensor in Vehicle #1 was located on the upper radiator support bracket 4.1 cm (1.6") right of the vehicle centerline. The sensor measured 5.7 cm (2.25") in length and 4.4 cm (1.75") in width and was hidden from normal view by the "Vehicle Emission Control Information" placard plate shown in photographs #27, #28 on page A-14. This sensor was not damaged in the crash.

27., 28. Views of the upper radiator support bracket showing the location of the crash sensor.

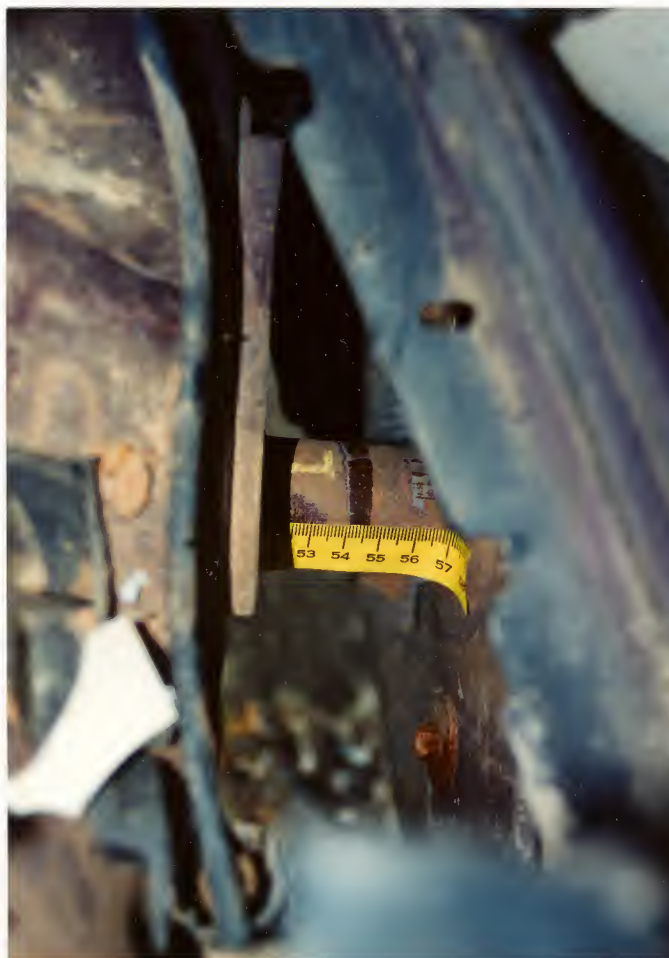
Components damaged in the crash included: the front bumper fascia, the grille; the left headlight and directional light assembly; the hood; the left front fender; the radiator; and the windshield. The left front bumper energy absorption device (EAD) was displaced rearward the full stroke value of 5.1 cm (2.0") with full restitution while the right EAD was not displaced (refer to photographs #29, #30 on page A-15).

29. View of the left bumper energy absorption device (EAD).

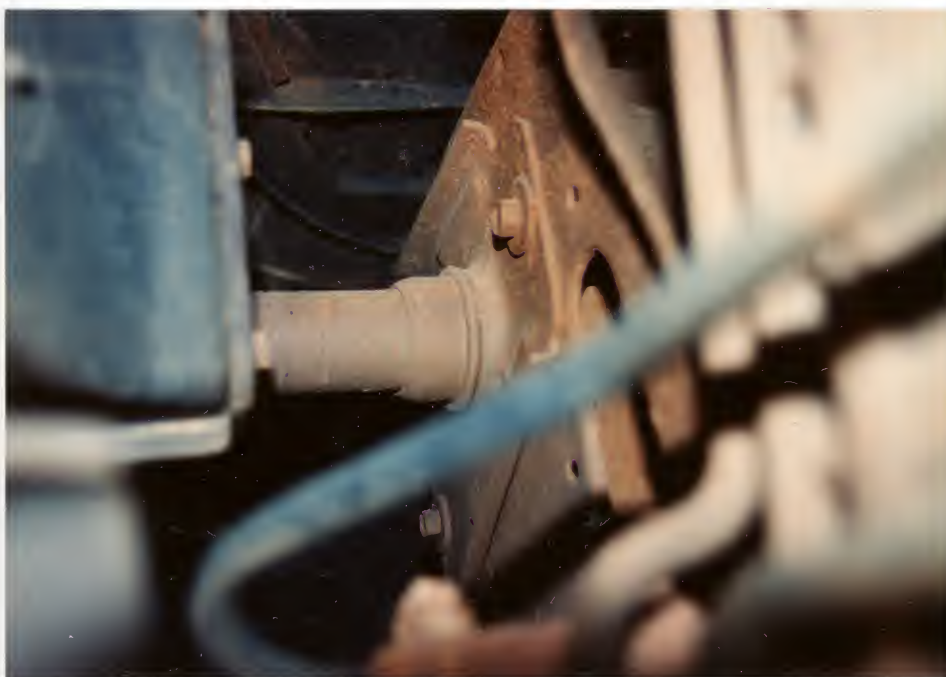
30. View of the right front bumper energy absorption device (EAD).

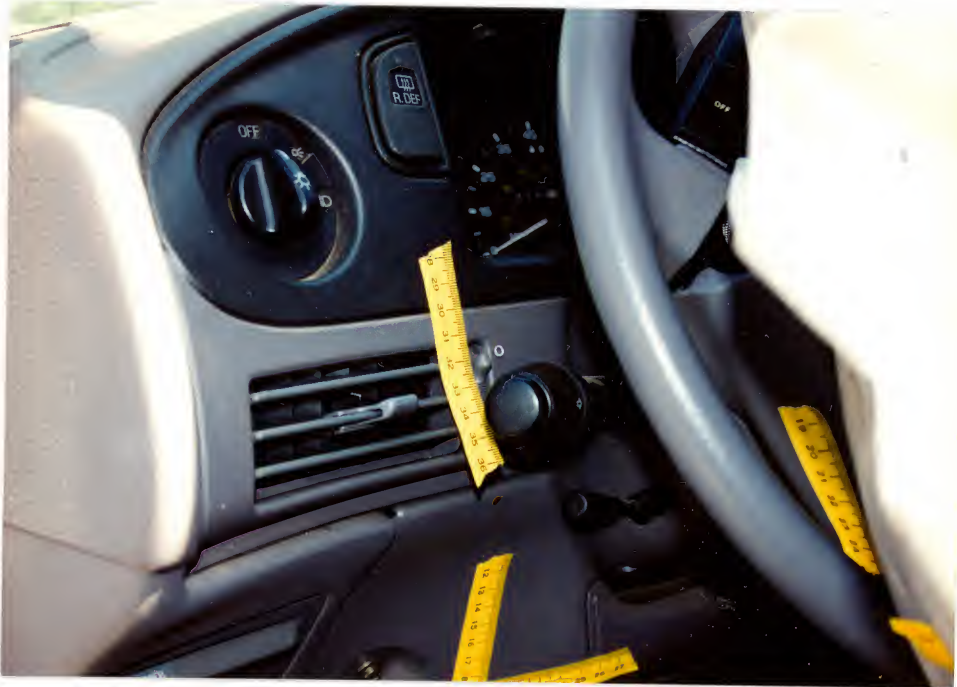
A light color transfer mark was noted on the mid instrument panel 55.2 cm (21.75") left of the vehicle centerline (refer to photograph #37 on page A-19). This was associated with a contact by the driver's left hand.

37. View of contact evidence on the instrument panel and knee bolster.

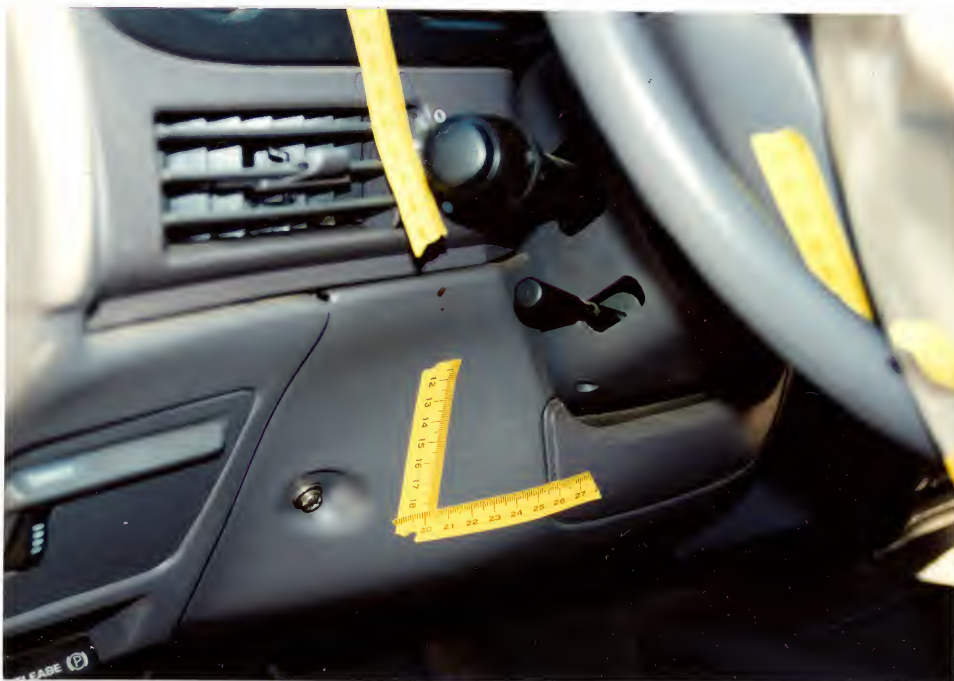
38. Close-up view of contact evidence on the knee bolster.

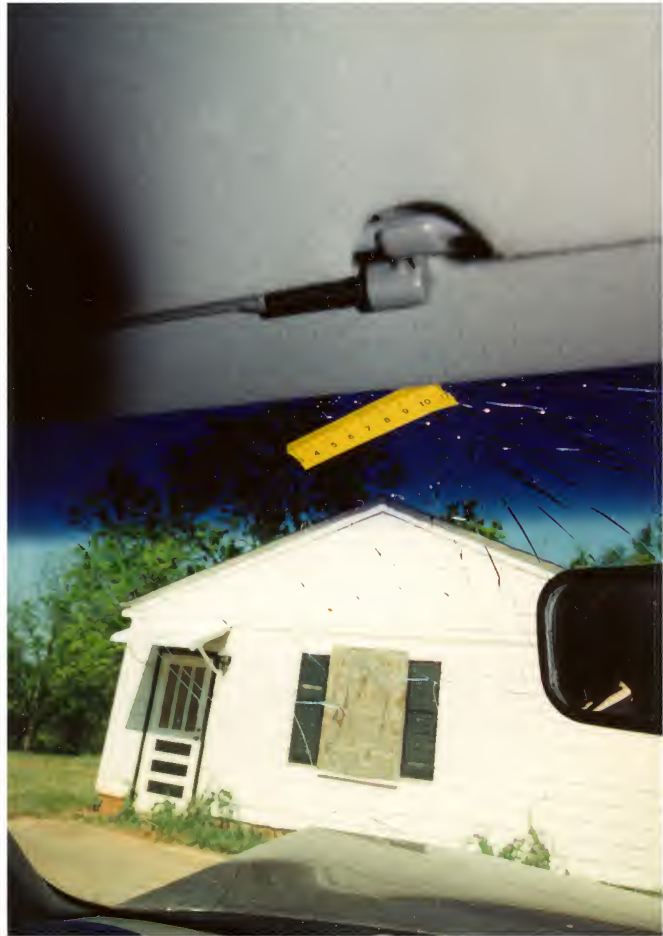
43. View of contact evidence on the windshield glazing just below the windshield header.

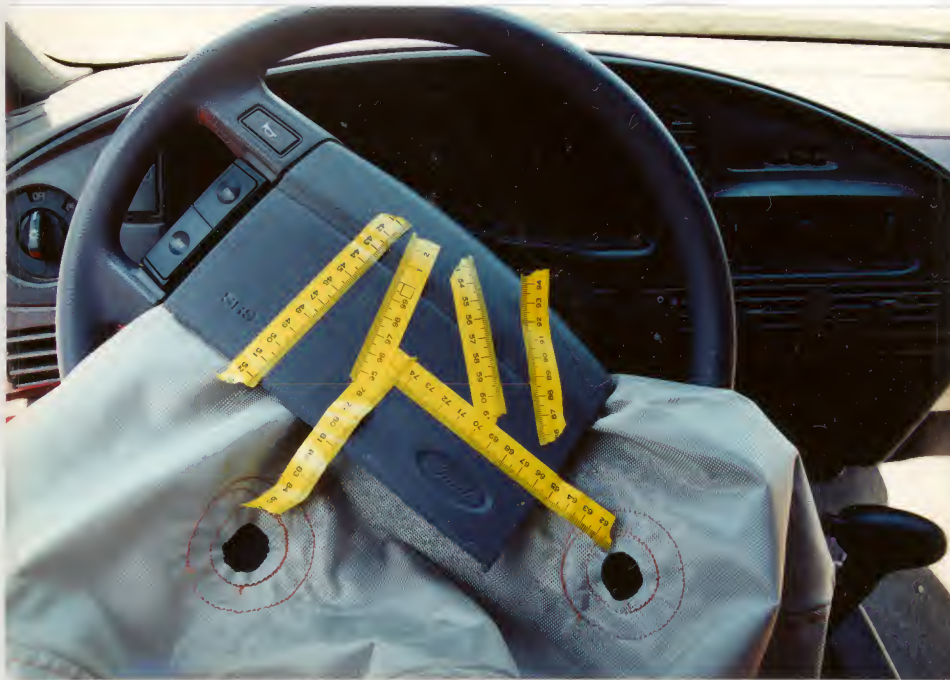
Damage to the interior was associated with driver contacts. The driver side air bag module cover exhibited several burnish marks and fabric coloration transfers (refer to photographs #44 - #46 on pages A-22, A-23). A dark blue/black transfer was observed along the entire upper cosmetic relief line which was located 3.0 cm (1.2") below the top of the upper flap. This transfer was consistent in color with the color of the driver's shirt (refer to photographs #57, #58 on page A-29).

The air bag module flaps exhibited several burnish marks and fabric coloration transfer marks (refer to photographs #44 - #46 on pages A-22, A-23) from contact with the driver during the deployment sequence. A dark blue/black transfer was observed along the entire upper cosmetic relief line located 3.0 cm (1.2") below the top of the upper flap which was consistent in color with the color of the driver's shirt (refer to photographs #57, #58 on page A-29). A significant burnish mark which measured 8.9 cm (3.5") vertically and 3.1 cm (1.25") laterally was located 3.1 cm (1.25") right of the left vertical tear seam and began at the horizontal tear seam line.

44. View of the driver side air bag module cover and the air bag vent ports located on the reverse side of the air bag.

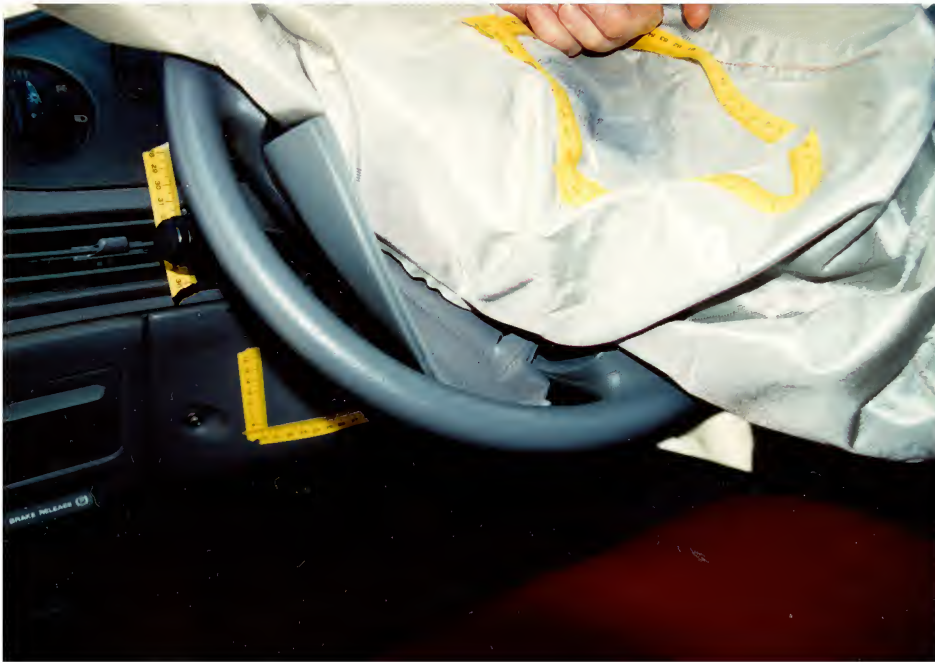
45., 46. Views of the driver side air bag module cover before and after the application of the calibrated tape.

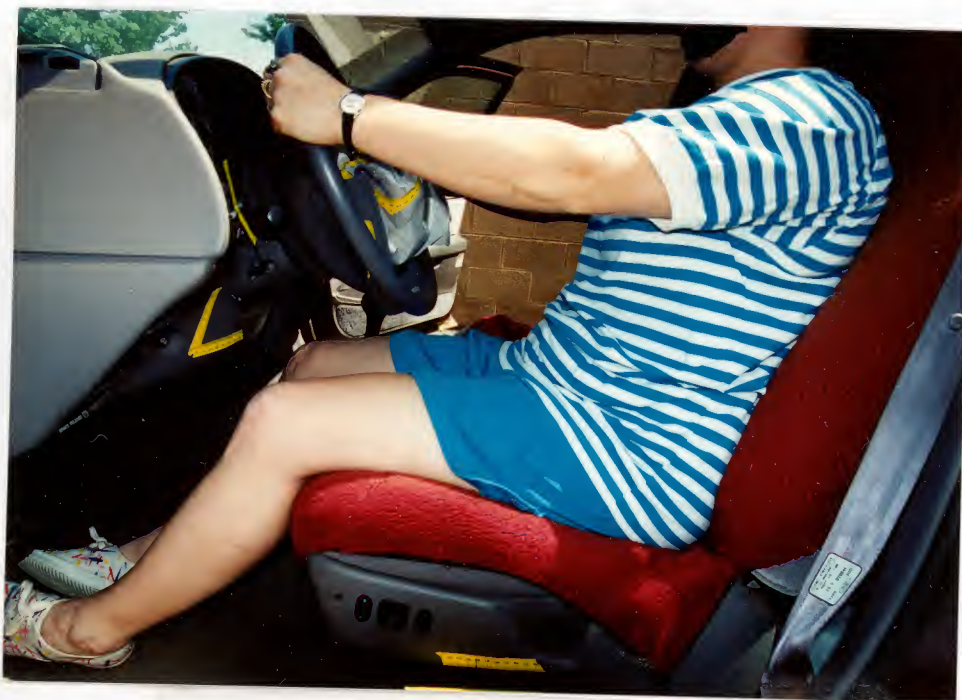
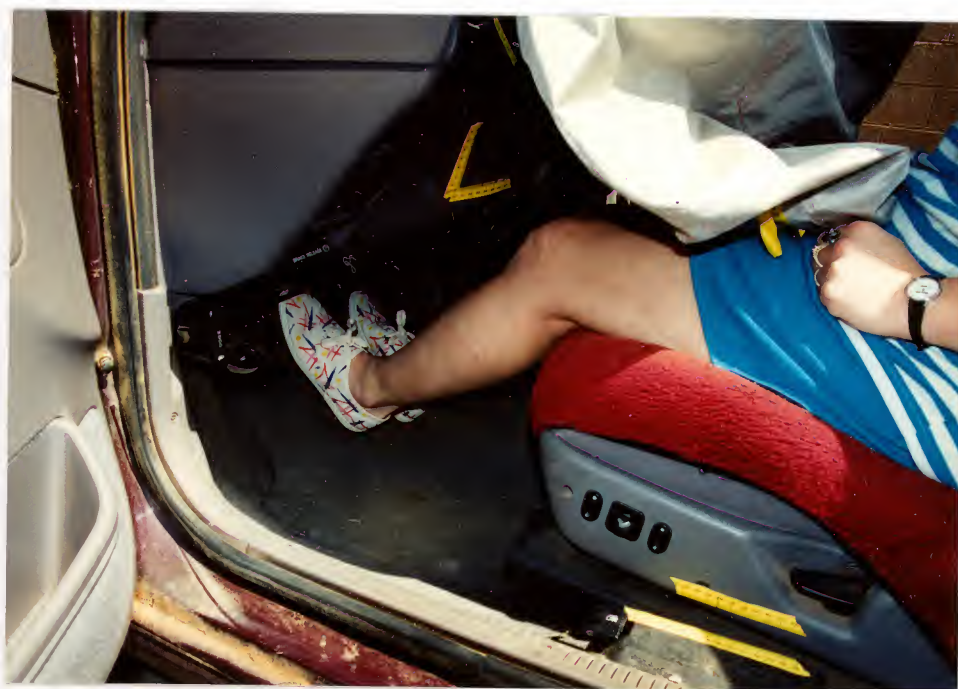
53., 54. Views showing the location of the driver's torso and lower extremities with respect to the air bag, steering wheel rim, and lower instrument panel.

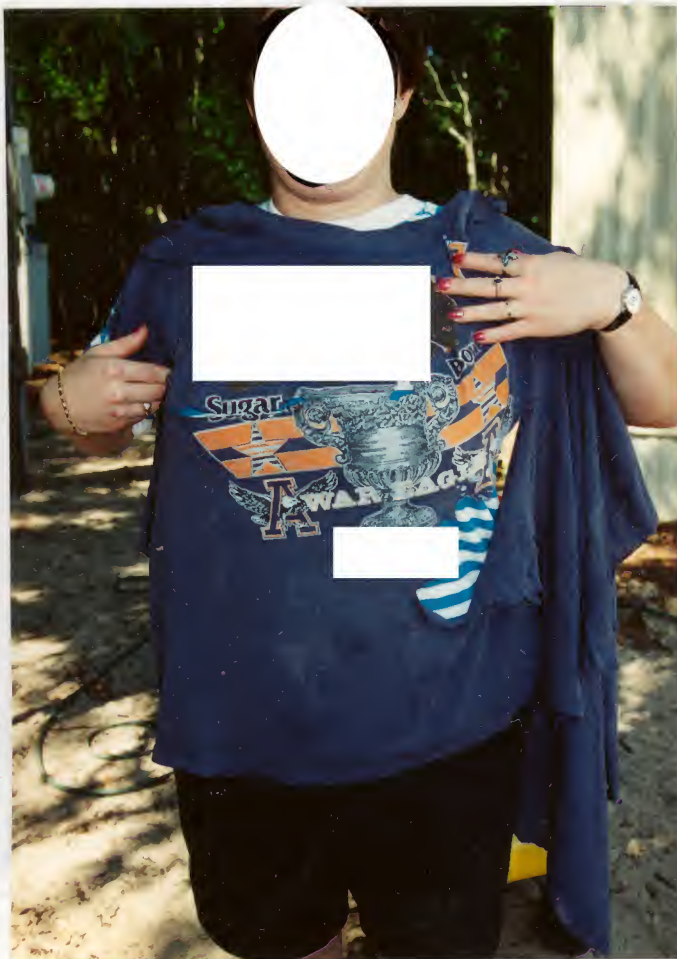
This contact was associated with the 17.1 cm (6.75") long angular rip noted on the driver's shirt located 30.5 cm (12.0") above the bottom and 20.3 cm (8.0") left of the centerline of the shirt. It extended downward to a point 13.3 cm (5.25") above the bottom and 6.4 cm (2.5") left of the centerline (refer to photographs #56 - #58 on pages A-28, A-29).

56. View of the shirt worn by the driver at the time of the crash.

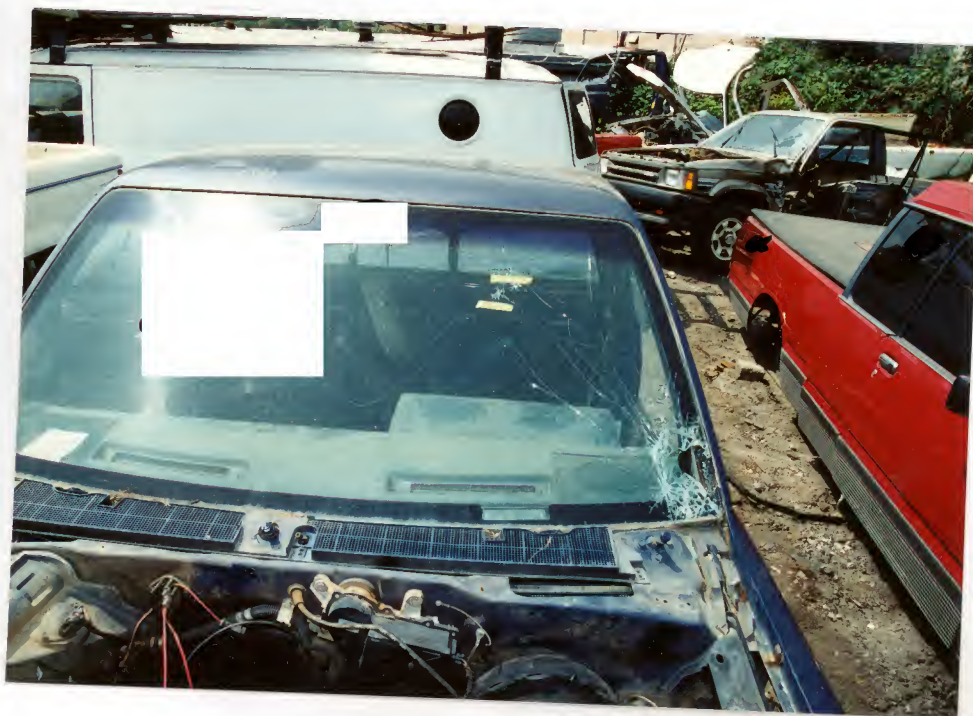
70. View of the damage noted on the windshield.

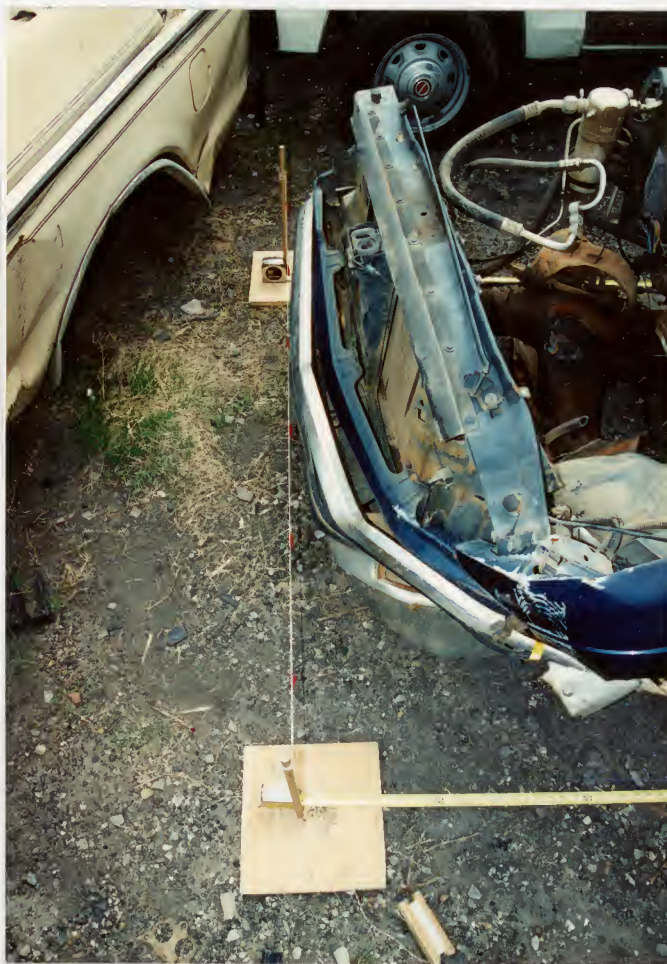
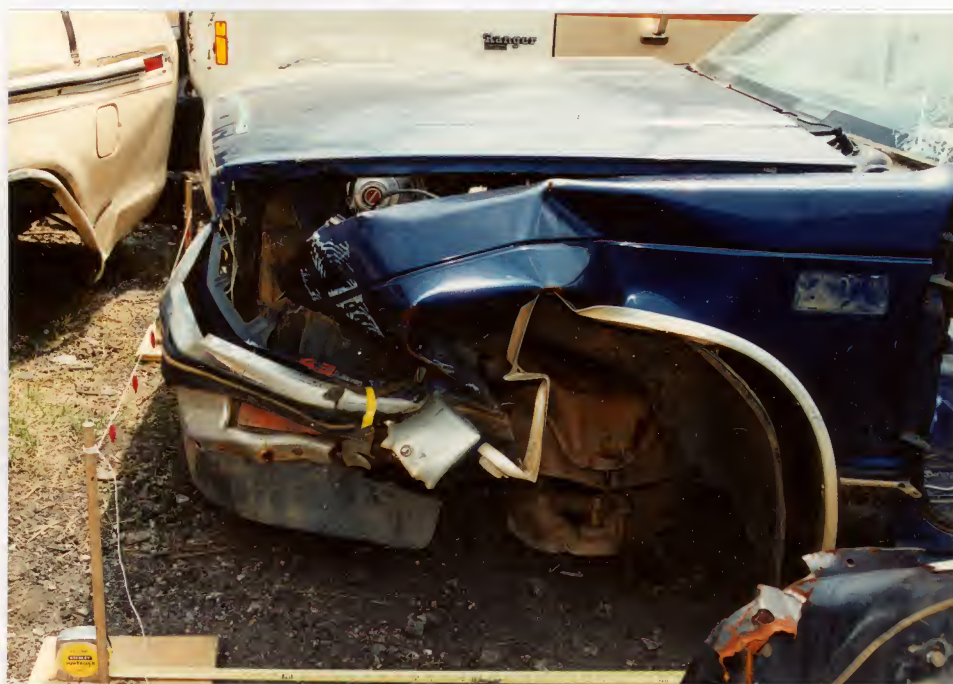
75. Lateral view of the front plane from the left side of the vehicle showing the extent of rearward crush.

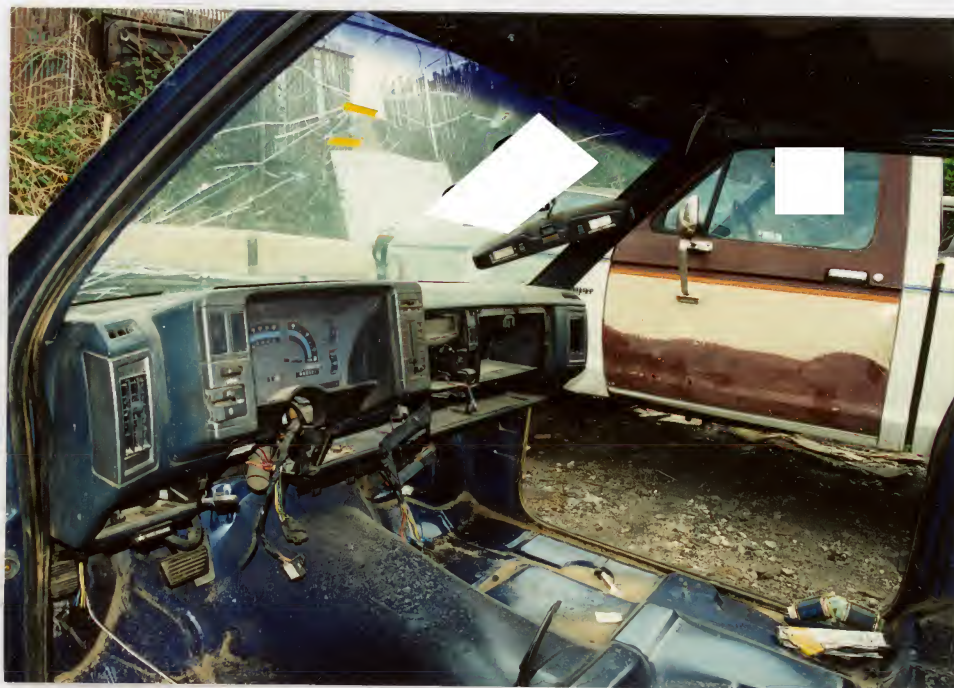
81. Angular view of the instrument panel (seats, steering column, and instrument panel accessories were removed by the salvage company).

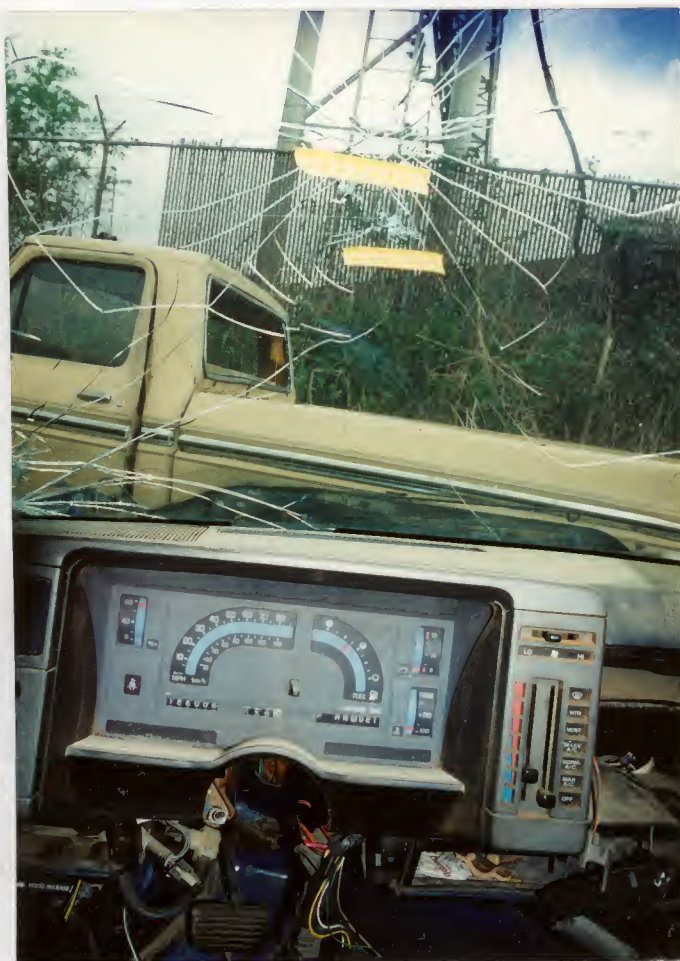
83. Contact evidence on the windshield.

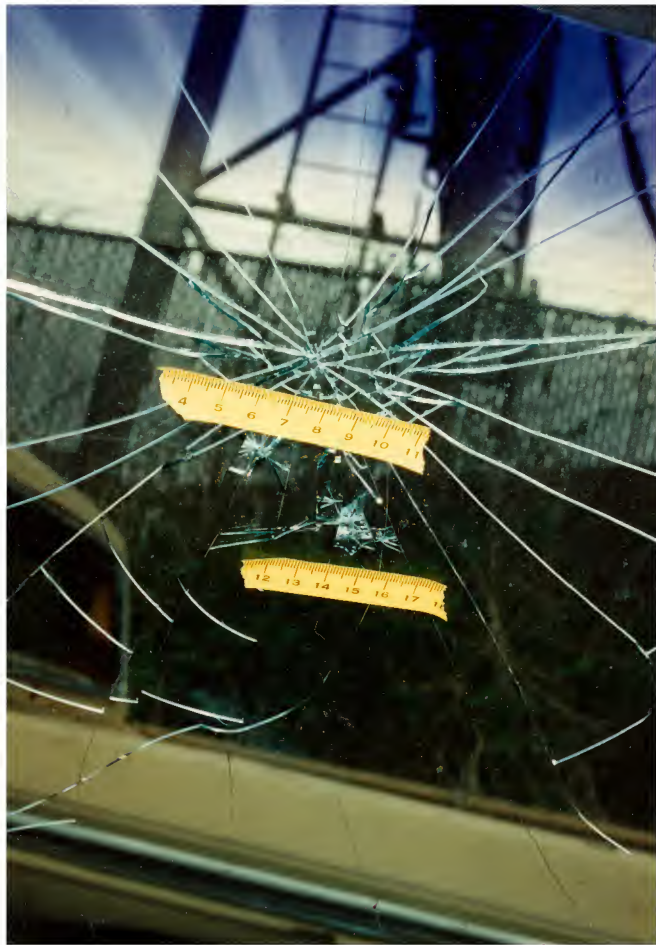
84. Close-up view of the hole in the windshield glazing.
